Corrosion evaluation of gusset plate connection removed from steel truss bridge

Summary

Keywords: corrosion, laser measurement, gusset plate, steel truss bridge.

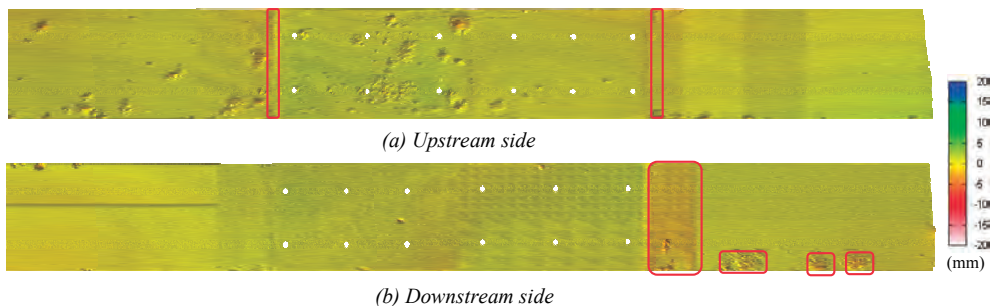
- 1) Localized corrosion had occurred on the outer surfaces of the upper chord members as shown in Figure 1. On the sides of tensile diagonal members, in the transition area between gusset plate and chord member, corrosion is more severe as a result of deformation.

Fig. 1: Corrosion depth distribution of upper chord on the upstream side

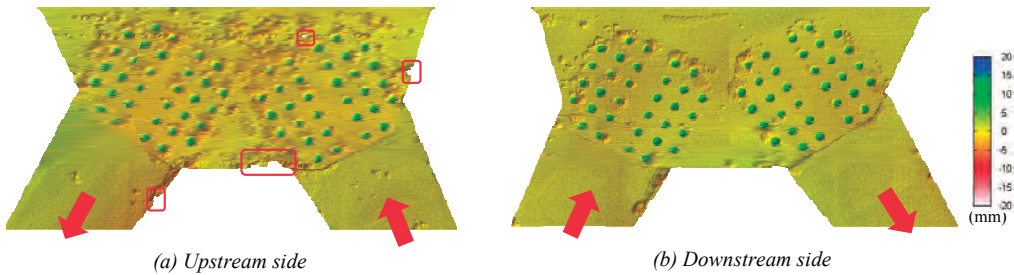
Fig. 2: Corrosion depth distribution of gusset plate of outer surface

2) Corrosion was more severe on the upstream side of the connection. Three holes had appeared, on the steel edges and at the end of compression members, as a result of severe corrosion. On the outer surface, localized corrosion had occurred over the whole gusset plate, as shown in Figure 2. As indicated clearly in Figure 3, on the inner surface, there was extreme corrosion on the flanges of the diagonal members, around the rivet heads, at the edges of the gusset plate and in the transition area between gusset plate and diagonal member flanges.

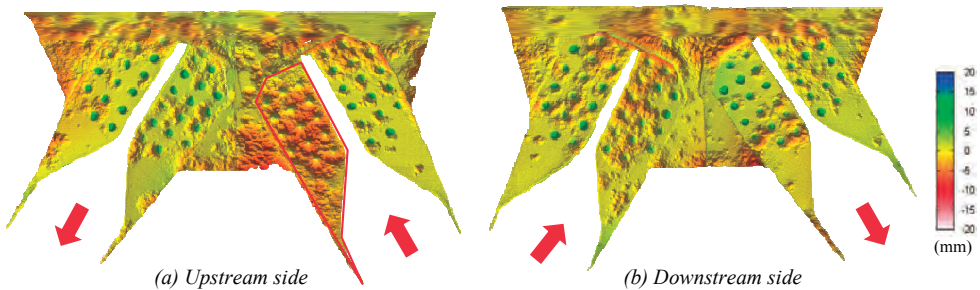
Fig. 3 Corrosion depth distribution of gusset plate of inner surfaces

4) The severe corrosion seen on the inner surfaces may have been caused by salt accumulation resulting from seaborne wind vortices.
