Vehicle Collision into Steel Pedestrian Bridges

Lauri SALOKANGAS

Niko SAUNA-AHO

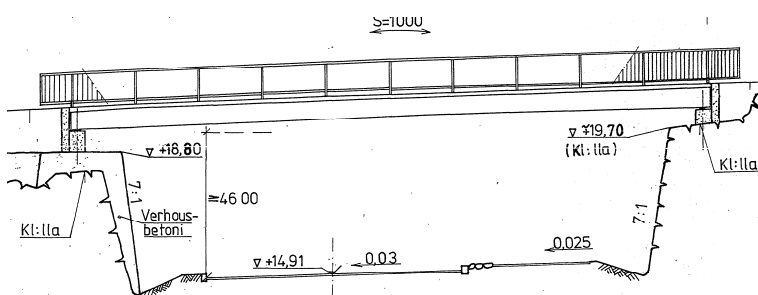
Fig. 1: Elevation of the collapsed pedestrian bridge.

The bridge was statically determinate, one span pedestrian steel beam bridge with a wooden deck. The length of the superstructure was 20.2 m, the span 19.5 m and the effective width 3.5 m, respectively. The free height for under-pass was more than 4.6 m (Fig. 1).
