Raising Existing Bridges to a Higher Navigable Clearance

To improve the navigation on the Juliana Canal, a waterway from the Netherlands to Belgium and France, two bridge crossings had to be raised by over 3.0 m. The raising project required a thorough consideration to the condition of all sub- and superstructures, their behaviour during raising and in raised positions, remaining service life etc. This paper presents the highlights of the project.

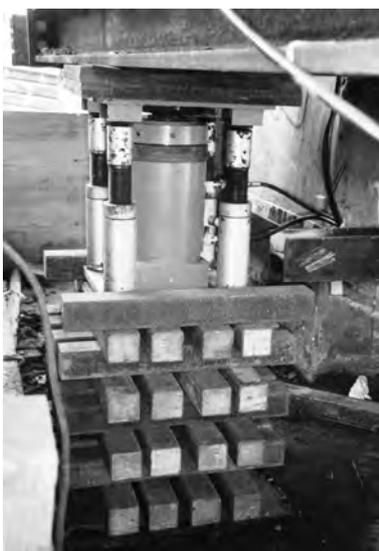
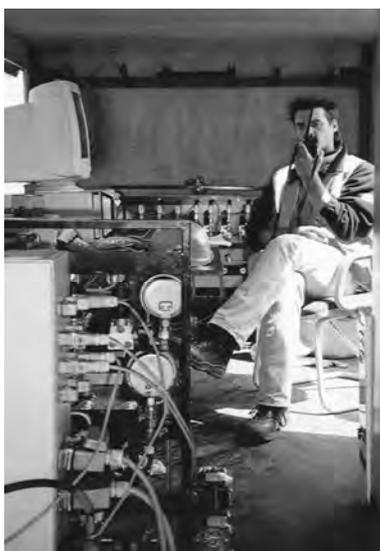
The jacking-up proceeded in steps of 100 mm, every step followed by the filling adjustment. The jack positions allowed for placing the filling bars alternately in both horizontal directions. Precautions were taken to provide sufficient stability under wind loads.

Fig. 3: Jacking point (left) and control room (right)

In the meantime, the bridge pillars and abutments were strengthened. Their elevating was scheduled to take place directly after the superstructure raising in order to limit the use of temporary supports. The load test results removed the last concerns about the superstructure condition. The jacking-up could proceed. Temporary supports and 12 jack-up units were installed under the superstructure (Fig. 3 left). All units were synchronized and computer controlled (Fig. 3 right) in such a way, that the level diversions did not exceed 5 mm during the entire jacking-up of over 3.0 m.

Each bridge was raised about 0.3 m above the desired level, to make space for the substructure levelling. Upon the completion of that, both bridges were lowered back to their final positions.
