DESIGN, CONSTRUCTION AND HEALTH MONITORING FOR A LARGE SPAN PEDESTRIAN BRIDGE

Summary

This paper focuses on design, construction and health monitoring for a floating pedestrian bridge cross two cliffs. The substructure of the bridge is located near cliffs. The superstructure of the bridge is a curved box girder supported by a tilting cable-arch system. A parabolic steel arch spans about 100 m between two cliffs and rises 25 m above cliff levels.

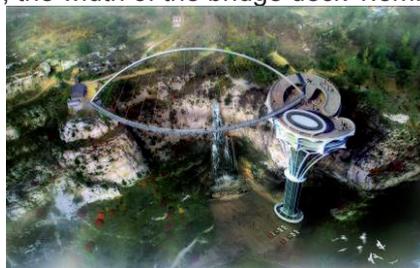
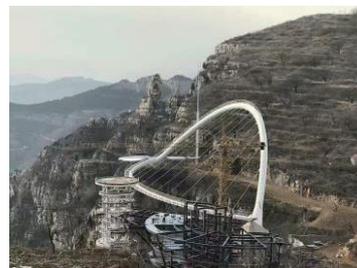
As shown in Fig. 1, here in the Tanxi Mountain tourist area, which is located in Zibo, Shandong Province, China, a tilting pedestrian bridge was constructed cross two cliffs, in which a inclined tube arch supports a plane curved girder through 13 cables. The span of the bridge is 103m and the length of the curved girder is about 125m, the inclined arch is a parabolic arch with the height of 25m, the angle between the arch and the girder is 60 degrees, the width of the bridge deck 1.8m.

Fig. 1. Pedestrian Bridge, Zibo, China, 2016, a) Sketch view, b) Photo by Haizhou Chen
