## Modern Solutions for Strengthening of Structural Elements

The paper deals with the results and recommendations based on experimental programmes.

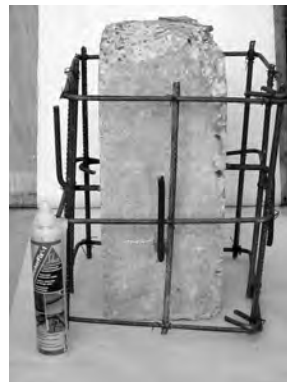
*Fig. 1: RC columns strengthened by RC jacketing*

The connection between the substrate (RC prism) and the added concrete (RC jacketing) were: concrete-to-concrete bond; bonding agent as epoxy resin; chemically (Fig. 1) or mechanically anchored steel connectors.

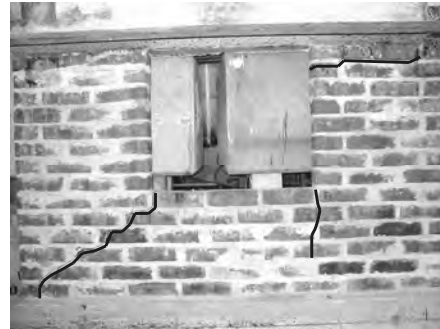
Masonry brick walls using mortar M25 and having a window opening were designed and manufactured as shown in Fig. 2 (scale 1:2).

During the tests the vertical load had a constant magnitude, while the horizontal load  $S$  was increased up to the failure. The failure and the crack pattern at failure for the un-strengthened masonry wall are presented in Fig. 2.

Fig. 2: Un-strengthened masonry wall failure and crack pattern

The un-strengthened masonry wall failure was characterized by cracking in different ways:

horizontal cracks at wall base – due to tension from eccentric compression; horizontal cracks at wall top – due to friction; inclined cracks starting at the window corner – due to main tension stresses.

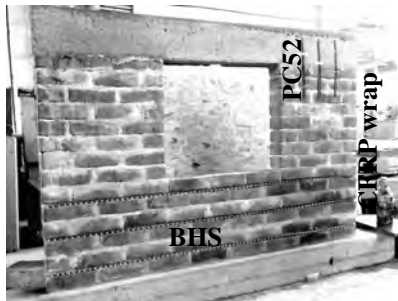
The strengthening proposals (Fig. 3) were selected function of the cracking pattern. Subsequently, were applied: vertical CFRP wraps placed on the masonry wall exterior edge; vertical Romanian High Adherence Steel Bar PC52 as near-surface-mounted-reinforcement; horizontal high adherence steel bars Brutt Helical System BHS as near-surface-mounted-reinforcement in the mortar layer.

Fig. 3: Masonry wall strengthening

Vertical and horizontal loads were applied on the top RC strap. The horizontal load simulated a seismic action. The first tests were done on the un-strengthened masonry wall until cracking and then strengthened (Fig. 3) and rested.

The initial masonry walls once cracked were strengthened by the previous different modern and efficient techniques and rested in order to find out the bearing capacity of the rehabilitated walls.
