# Rehabilitation of Earth Retaining Wall for Slope Failure, due to Strength Reduction and Seismic Acceleration, Considering Nonlinear Soil-Structure Interaction

Jörg-Martin Hohberg

IUB Engineering Ltd., Bern, Switzerland

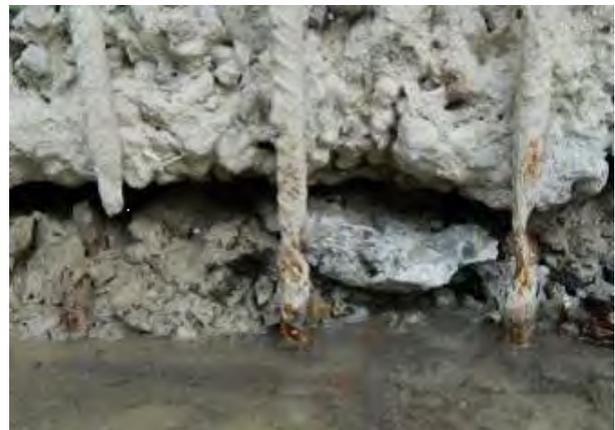
Figure 1. Typical loss of rebar cross-section due to advanced corrosion at the earth-covered rear side of an angular retaining wall [3]

Laboratory research requires a starting decision as to what is the mechanism to be investigated. From a classical structural engineering point of view, it is the rotational capacity of a retaining wall subject to corrosion of reinforcement, particularly the vertical one on the rear side (uphill), where honeycombing due to an untight cold joint between slab and wall may occur. The bottom reinforcement of the base slab seems of lesser interest, even though it is strained by the same corner bending moment and may be subjected to about the same water pressure as the cold joint, albeit less exposed due to a lean concrete layer under the slab.
