Condition Assessment of Steel Riveted Roof of Heritage Building in Sofia, Bulgaria

Abstract

The findings of a recent survey on the steel roof structure of an early-twentieth-century building located in Sofia, Bulgaria are reported. The steel roof structure is supported by solid masonry walls around the building perimeter and on slender cast-iron columns along two interior longitudinal lines. The south part of the building was severely damaged during the bombing raids over Sofia in WWII. The building underwent a major refurbishment within the 1995-2000 period accompanied by detailed survey and condition assessment of the steel roof structure. In 2020 the authors carried out a survey for condition assessment of the steel roof structure including checks of riveted connections, analysis of chemical composition by OES metal analyser and inspection of the roof cladding components by endoscopic device.

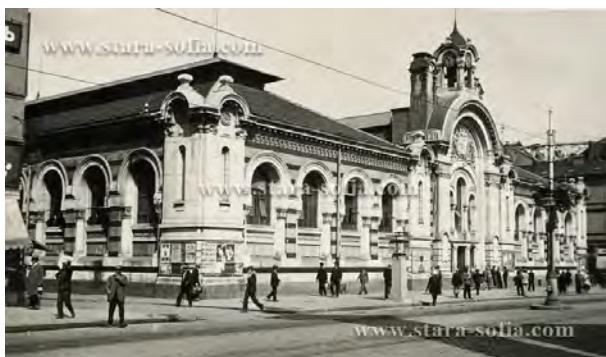
Figure 1. Authentic photo of the building

The paper presents and discusses the findings of a recent survey on the steel roof structure of a heritage building located in Sofia, Bulgaria. The building was originally designed to host the central market of the town and its construction was completed in 1911 (Fig. 1).

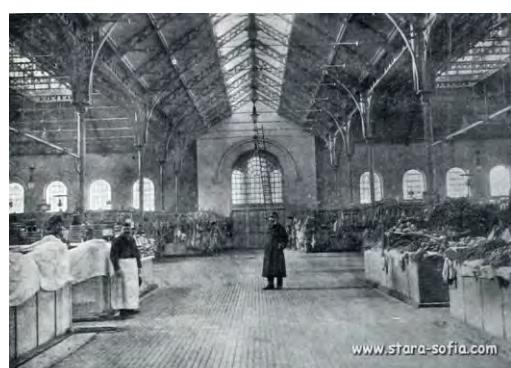
Figure 2. Interior view of the building

The steel riveted roof structure was fabricated abroad. It is supported by solid masonry walls around the building perimeter and by slender cast-iron columns arranged along the two interior longitudinal lines (Fig. 2). The roof framing in the transversal direction has a three-span layout and consists of three duo-pitched rafters with horizontal tie-rods spaced at 4,0 m bays.
