Effect of Regrinding on the Edge Strength of Tempered Glass

Katharina Lohr, Bernhard Weller

Abstract

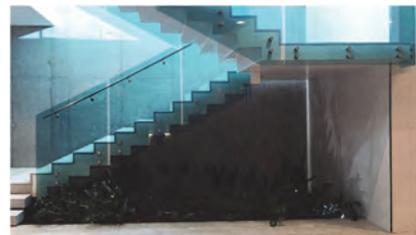
Figure 1. Example of a railing construction with visible, untreated edges

Figure 1 shows a railing construction in which the glass edge is located in the immediate field of view of the user. In this example, the glass edges were not reworked. In figure 2, a juncture in the railing area can be seen which displays the irregular

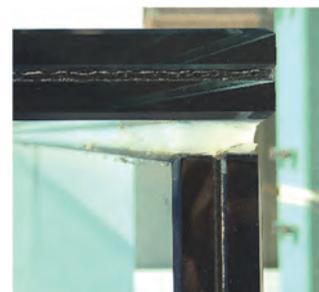
Figure 2. Laminated glass edges with edge displacement and irregularity of the interlayer

behaviour of the interlayer (horizontal glass) as well as edge displacement (vertical glass).
