Macdonald Bridge Suspended Spans Deck Replacement: Construction Engineering Challenges and Solutions

D. Radojevic, Ph.D., P.Eng. and K.F. Kirkwood, M.E.Sc., P.Eng.

COWI Bridge North America

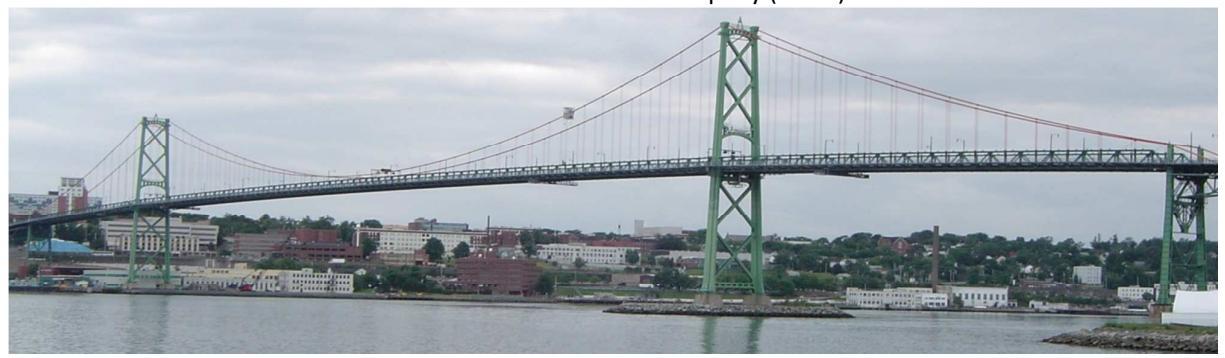
Figure 1: Angus L. Macdonald Bridge, Halifax, Nova Scotia, Canada (Pre-Replacement Condition)

The Angus L. Macdonald Bridge, shown in Figure 1 and Figure 2, opened in 1955 and connects Dartmouth and downtown Halifax, Nova Scotia. The suspension bridge is 762 m long and the overall length, including approaches, is 1,347 m. The deck of the suspended spans has reached the
