## Retrofitting of AYALA Bridge, an historic steel bridge in Manilla (Philippines)

Vanessa BUCHIN-ROULIE, Nicolas KACZKOWSKI, Alexandre GROS, Fabien TESSON

*Freyssinet International, Reuil-Malmaison, FRANCE*

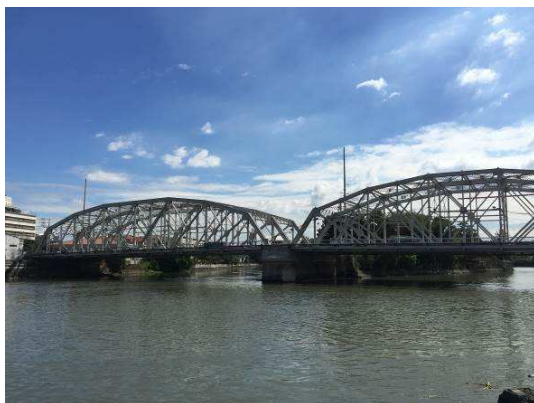
Figure 1. Global view of Ayala Bridge

It is comprised of 2 independent steel arch bridge of 61,6 meters (south span) and 73,8 meters (north span), constructed with 3 trusses connected together. Transversally, the deck is composed of a concrete slab supported by stringers beams. The deck of 25,9 meters width supports 4 traffic lanes each of 3,05 meters and 2 sidewalks.

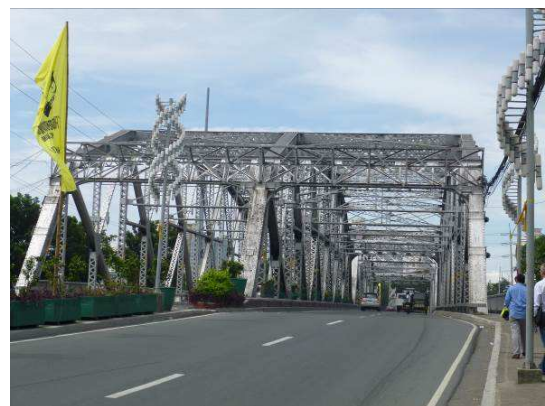
Figure 2. The 3 arches connected together
