# Structural Widening of 2-Span Continuous Prestressed Concrete Bridge: Structural and Seismic Implications

John Philp

McElhanney Consulting Services Ltd, Vancouver, BC, Canada

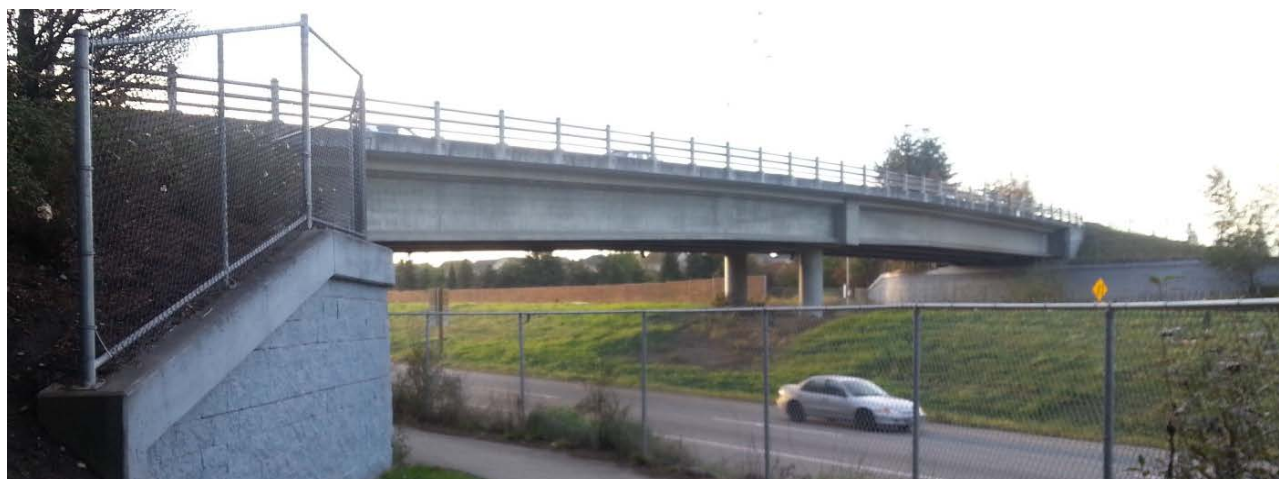
Figure 1. Existing 208 Street Overpass

The existing 208 Street Overpass is in Langley, in the lower mainland of British Columbia and carries traffic on a North-South alignment over Highway 1. See Figure 1 above.

One lane of traffic is provided in each direction and pedestrians are accommodated by raised sidewalks on each side of the bridge but there is no dedicated cycle lane. A support pier located in the

median of Highway 1 supports the bridge superstructure creating a continuous 2-span arrangement.
